## Test Report

No. 2026034/SD

Sample Description : 1. STATIC INTERCEPT BAG (CLEAN IRON METAL SHEET)  
2. STATIC INTERCEPT BAG (FRESH SILVER COATED PCB)  
3. CORROSION INTERCEPT BAG (CLEAN COPPER SHEET)

Test Requested : Salt Spray (Fog) Test (ASTM B117-03)

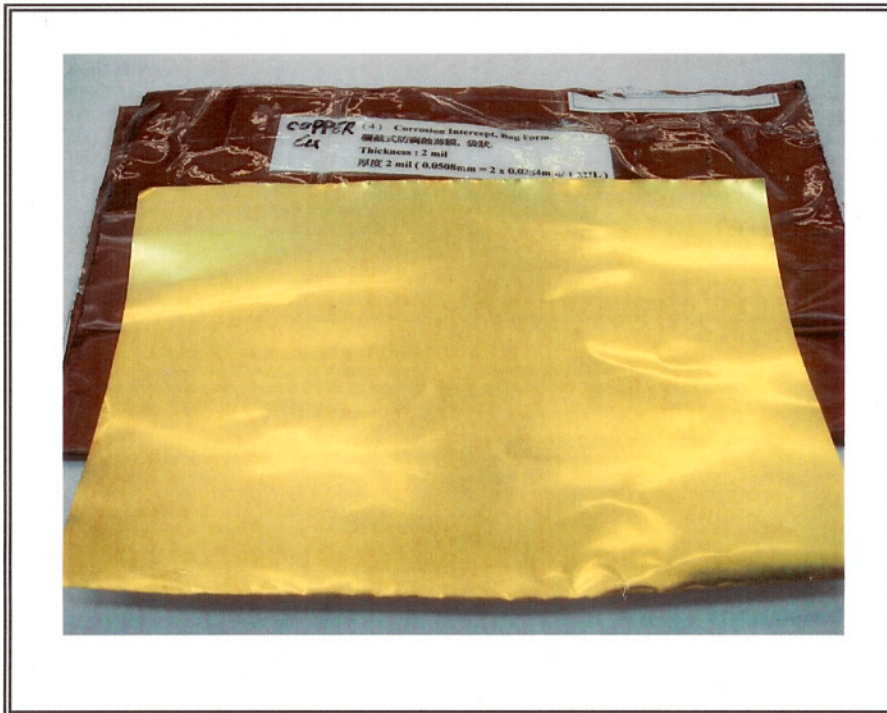
Sample B (After Test)  
SGS authenticate the photo on original report only

<u>Specimen</u>	<u>Observation</u>
A	6
B	6
C	6

- A Fresh Silver coated PCB packed into a static intercept bag with thickness 3 mil.
- B Clean Copper sheet packed into a corrosion intercept bag with thickness 3 mil.
- C Clean Iron Metal Sheet packed into a static intercept bag with thickness 3 mil.

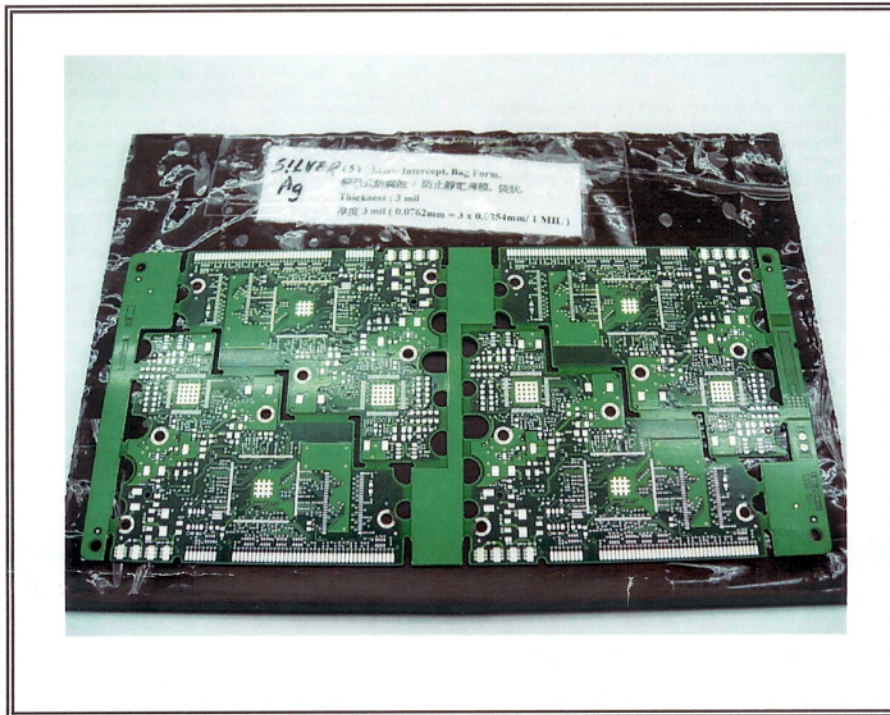
Sample A (After Test)  
SGS authenticate the photo on original report only

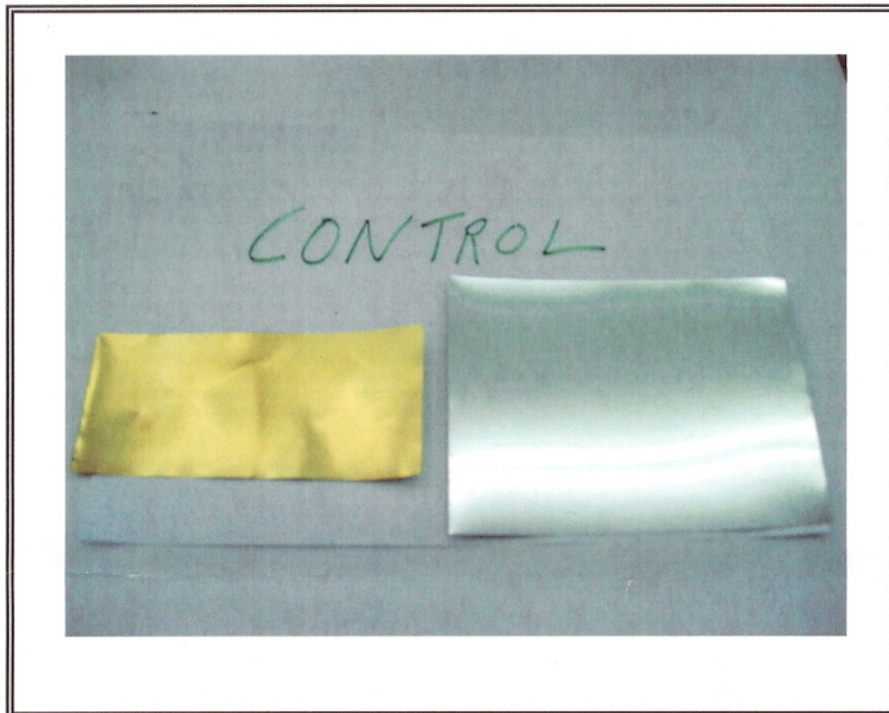
Sample C, B (Before Test)  
SGS authenticate the photo on original report only
